SFRA Capability for detection of deformation in Transformer windings: A field experience of 400kV 167MVA single phase ICT

Abstract – Sweep Frequency Response Analysis has become very popular now – a - days due to its ability to provide comprehensive information regarding mechanical as well as electrical condition of power transformers. The SFRA is a signature test and provides better information when evaluation of Transformer condition is done by comparing actual set of SFRA results with reference results. This field experience refers to 400/220/33KV ICT bank, formed with three single phase units – each with capacity of 167MVA. Heavy fault current was fed through ICT due to failure of LA provided on external delta formation of Tertiary winding. Mechanical defects / deformation occur ostensibly due to short circuit current flowing through transformer winding in case of terminal faults i.e. fault adjacent to / on the power transformer. To ascertain mechanical integrity of power transformer, SFRA test is carried out and is supported by other tests i.e. capacitance and tan delta measurement etc. The test results reveal that SFRA is capable of providing more information about mechanica

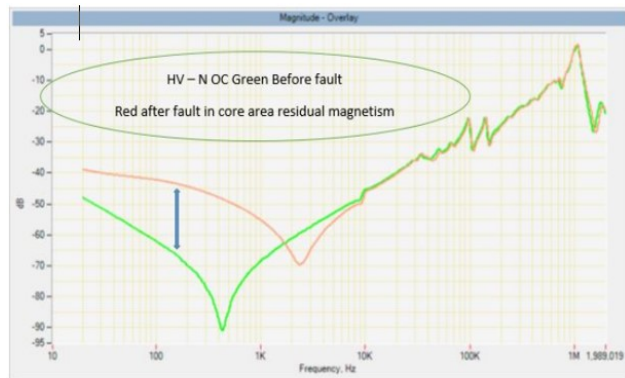
Fig. 4. SFRA of HV winding comparison with base result

In SFRA graphs for HV winding, difference was noticed in core area (low frequency region), while there was no any deviation in winding area (high frequency region). The difference in core area might be due to residual magnetism. SFRA carried out for LV winding with neutral bushing and deviation noticed in low frequency area - same as noticed in

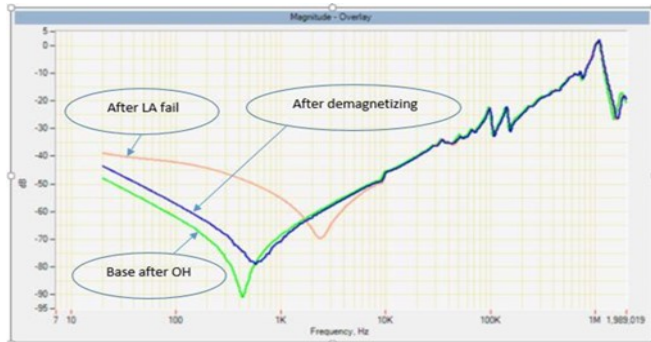
For verification the effect of residual magnetism, demagnetization carried out for the transformer and once again SFRA test carried out for all windings individually. After demagnetizing, the SFRA trace of “H.V. – Neutral” in low frequency area almost matched to the base fingerprint as shown in figure 8.

Fig. 8. SFRA of H.V. winding after demagnetization

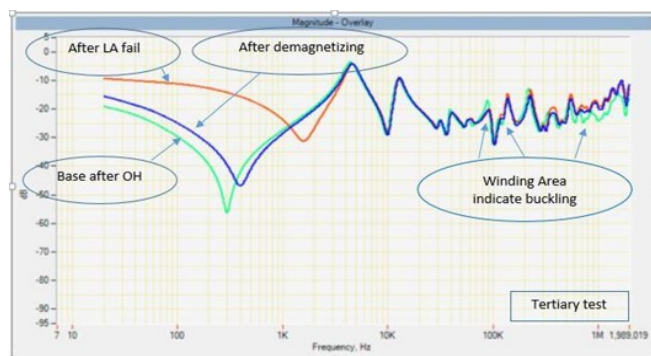
After demagnetizing, the trace of “L.V.-Neutral” in low frequency area almost matched to the base fingerprint as shown in figure 10.

Fig. 10. SFRA of tertiary winding after demagnetization

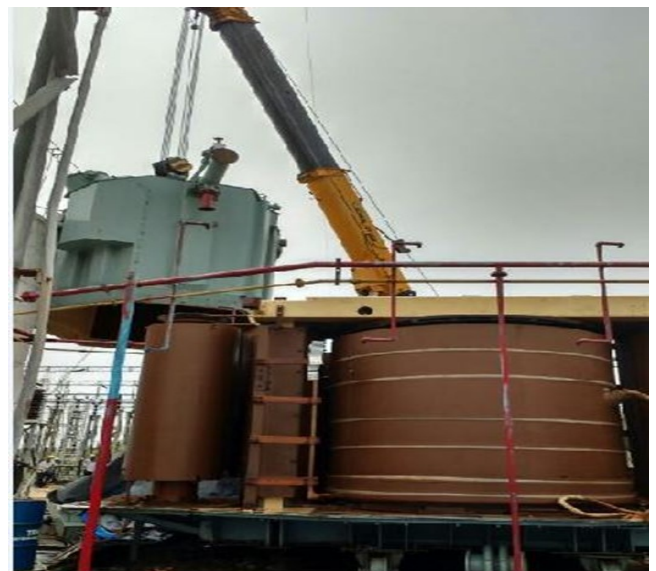
All test results found normal. Difference noticed in SFRA test results of tertiary winding indicated hoop buckling of tertiary winding, and same supported by capacitance and tan delta test, hence it was decided to inspect the transformer at site by lifting main tank. After removal of oil, thorough inspection of winding was carried out and nothing found abnormal in the transformer. No any black carbon particle or copper particle found inside main tank. After completion of internal inspection oil, filtration and drying out process for power transformer was carried out. All the required tests performed again. All the test results were found satisfactory or within permissible limit. The distortion in tertiary winding indicative from SFRA results - could not be observed / visualized after opening of transformer, as tertiary winding being innermost winding was surrounded by HV-IV winding - covered with hard board insulating cylinder. So nothing can be visualized for tertiary winding in inspection - as shown in figure 11.

Fig. 11. Inspection of active part of transformer

As transformer tank was bell type, huge crane required for lifting of main tank of power transformer. After analysis of all tests results and internal inspection, it was concluded that there was hoop buckling in tertiary winding. The conclusion was drawn from SFRA results and supported Capacitance and tan delta test results. The deviations recorded in SFRA and tan delta test results were within permissible limit, which indicated that the deformation was minor in nature. Deviation in SFRA and tan delta results had led to apprehension, however deviations were within permissible limits. Present available analytical tool of SFRA also didn't indicate any abnormality with Transformer windings.

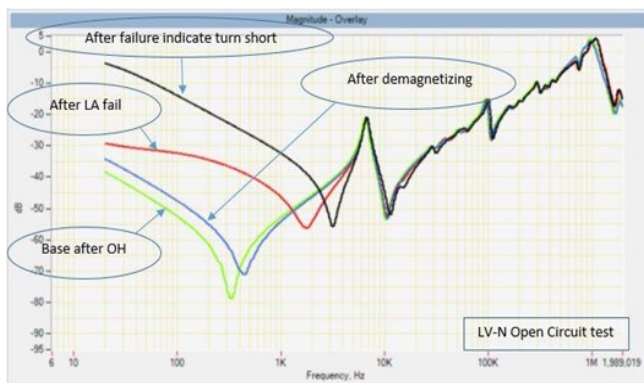
Fig. 13. SFRA of L.V. winding after tripping

As shown in figure 13 all four nos. of SFRA compared, in low frequency area i.e. 10Hz to 100 Hz, indicate turn to turn short. However, there was no deviation in winding area i.e. higher frequency and middle frequency which means that turn to turn short in other winding not in LV winding.
